# **RESERVE STUDY**

# Moss Creek of Hillsborough Homeowners Association, Inc.

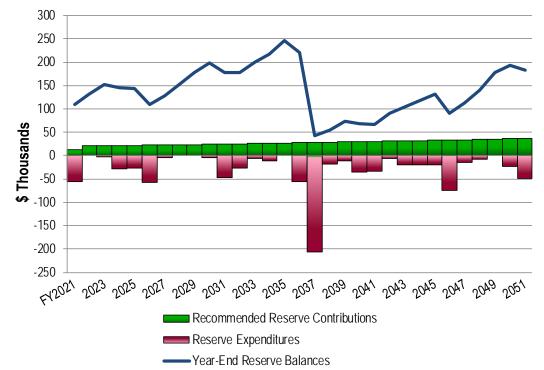
#### Moss Creek of Hillsborough Recommended Reserve Funding Table and Graph

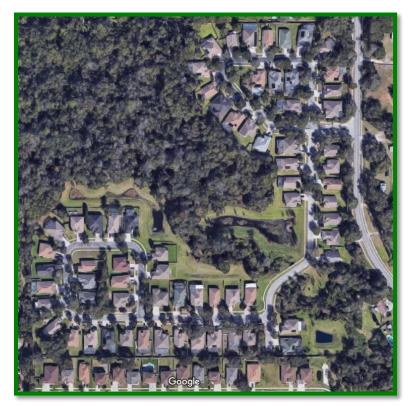
Our investigation includes Reserve Components or property elements as set forth in your Declaration. The Expenditure tables in Section 3 list the elements contained in this study. Our analysis begins by segregating the property elements into several areas of responsibility for repair and replacement.

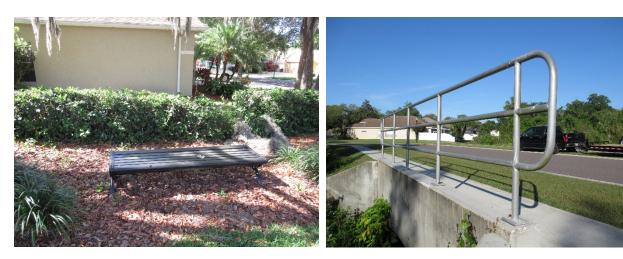
Bench at the gate entry

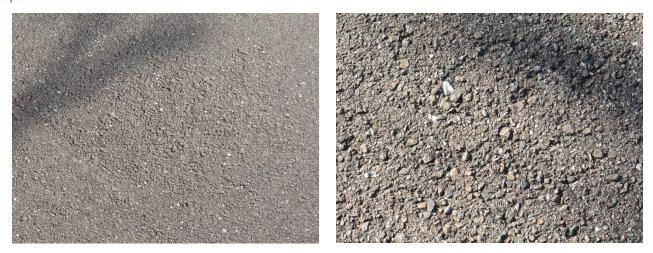
Asphalt pavement with mild raveling

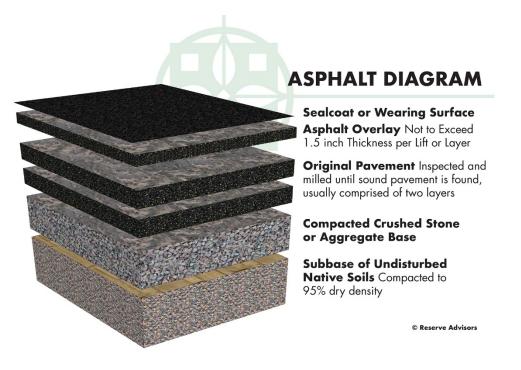
The manner of repaving is either a mill and overlay or total replacement. A mill and overlay is a method of repaving where cracked, worn and failed pavement is mechanically removed or milled until sound pavement is found. A new layer of asphalt is overlaid atop the remaining base course of pavement. Total replacement includes the removal of all

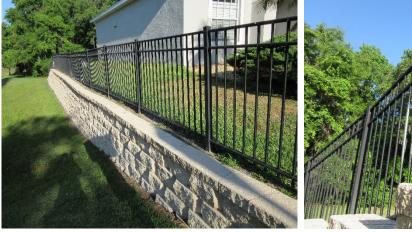
Aluminum fence on Moss Island Drive overview

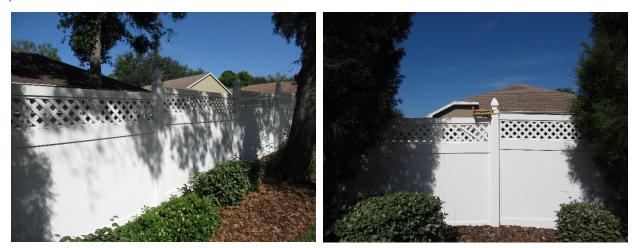
Vinyl fence overview

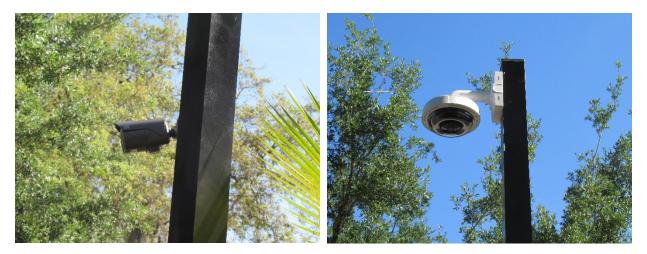
Single surveillance camera

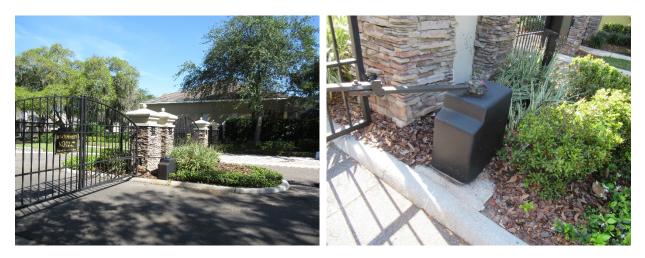
## Condition: Good overall

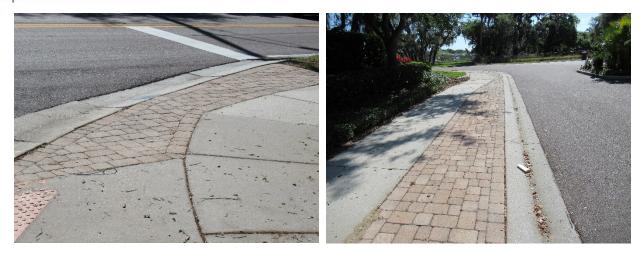
Masonry pavers at the entrance

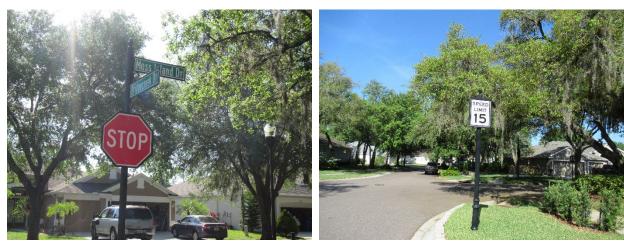
Stop sign with street addresses overview
